Keyur Choksi
209 Sprain Rd.
Scarsdale, 10583
HIN™: 105834434
Email: keyur.choksi@gmail.com
Inspection Date: 06-07-2014

RHI
Andrew Rybak
1 Mark Lane Hopewell Junction, New York 12533
Phone: (845) 797-1656
E-Mail: andy@rybakhomeinspections.com

Full Report

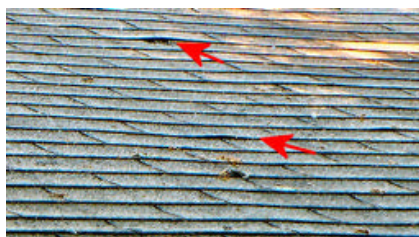
06/19/2014 Noted lifting shingles tiles on roof. This may/will cause water intrusion. Recommend remediation by a qualified contractor.

roof shingle stress

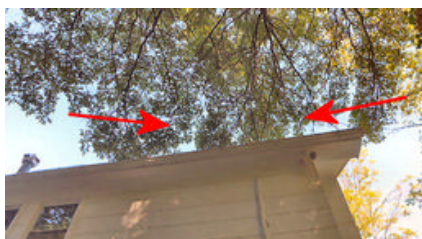
06/19/2014 Trees are overhanging roof and are within 10 feet of roof vertically. Recommend pruning trees so they're at least 10 feet above roof, or don't overhang the roof.

trees overhanging the gutters

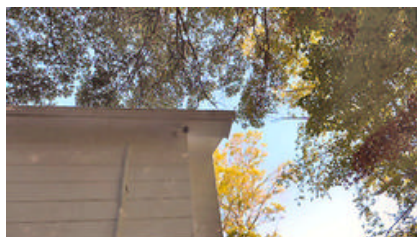
trees overhanging the gutters-a closeup

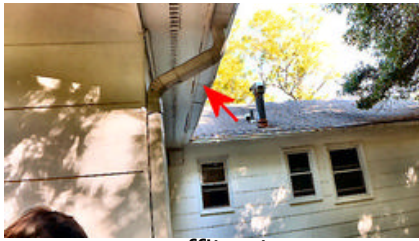
06/19/2014 Recommend cleaning gutters. This will help keep water away from soffit surfaces and foundation.

soffit rot

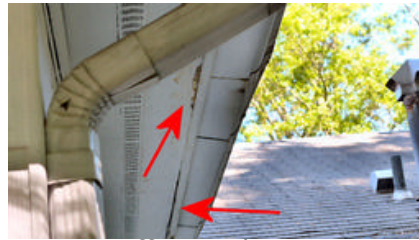
soffit rot closeup

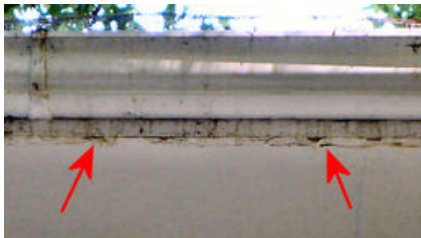
rotten wood behind the gutter - a closeup

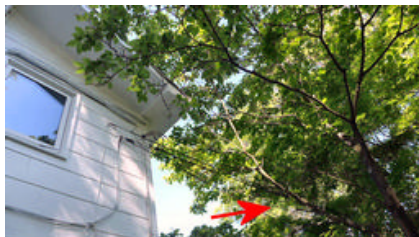
06/19/2014 Service wires from pole are threatened by tree overhang and should have Electric Company inspect and provide remedy.

electrical service in the tree branches

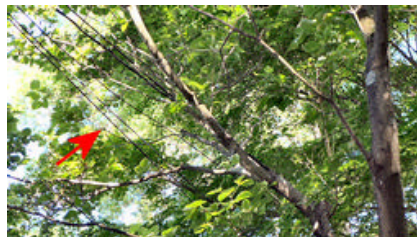
electrical service wires in trees - a closeup

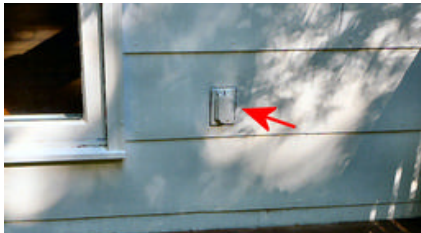
external wall outlet. not GFI -ed

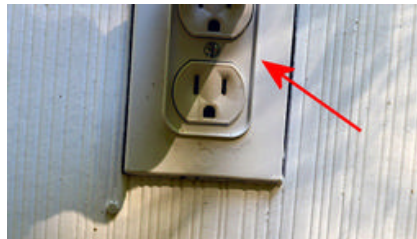
external outlet not GFI -ed

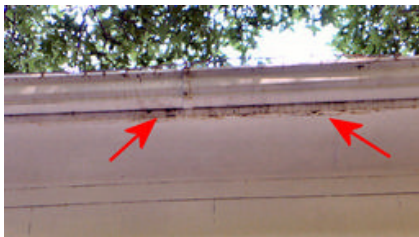
06/19/2014 Wood trim shows signs of deterioration, requires repair and repainting.

rotten wood behind the gutters

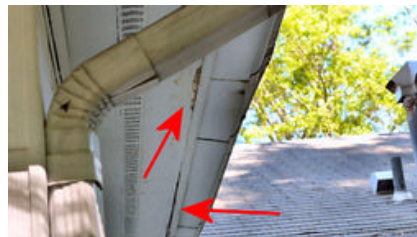
soffit rot closeup

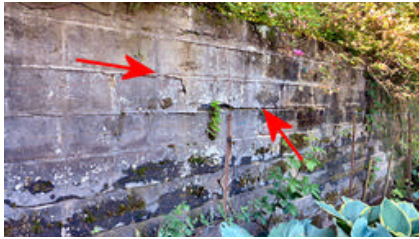
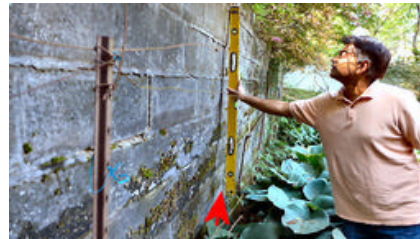
Noted cracks in the tall(>6ft) retaining wall behind the house. The retaining wall shows a vertical tilt from its perpendicular which indicates that a significant pressure is building up behind the wall. For one, a huge oak tree, in close proximity of the wall creates a significant pressure on the retaining wall compromising the retaining wall's stability. There exists a relatively high risk that the retaining wall will continue to tilt creating a liability risk. I recommend that a professional-contractor is employed to assess the situation

retention-wall relative stress

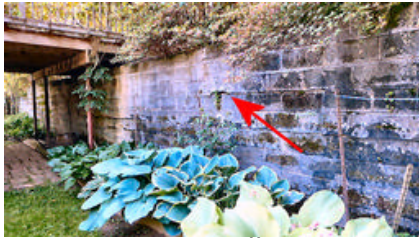
retention-wall stress

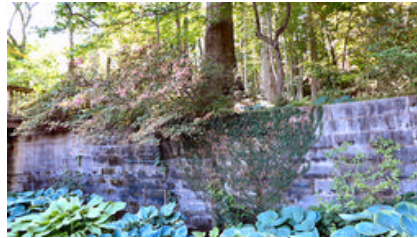
massive tree proximity to the retaining-wall

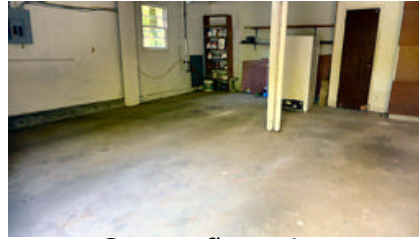
Noted many garage floor settlement cracks. Probably the single most common reason for early cracks in concrete is plastic shrinkage. When the concrete is still in its plastic state (before hardening), it is full of water. This water takes up space and makes the slab a certain size. As the slab loses moisture while curing it gets a bit smaller. Because concrete is a very rigid material, this shrinking creates stress on the concrete slab. As the concrete shrinks, it drags across its granular subgrade. This impediment to its free movement creates stress that can literally pull the slab apart. When the stress becomes too great for the now hardened concrete, the slab will crack in order to relieve tension. i recommend a qualified contractor to assess the situation.

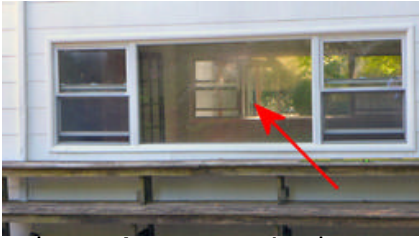
I noted several double-insulated-window panes that are opaque. This indicates that the vacuum seal has been compromised and the thermal-insulating performance of that assembly is basically gone. This can not be repaired. To return to the proper thermal performance of the window area ...the opaque-ed pane windows should be replaced. I recommend that a qualified window-replacement contractor be hired to assess the situation

window haze. A compromised vacuum seal

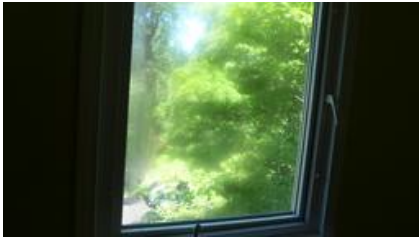
Window haze. A compromised vaccum in window panes

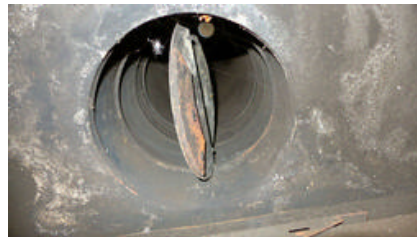
Fireplace. Chimney flue.

Recommend a level 2 inspection performed by a qualified chimney sweep. This inspection will determine the condition of the flue liner.

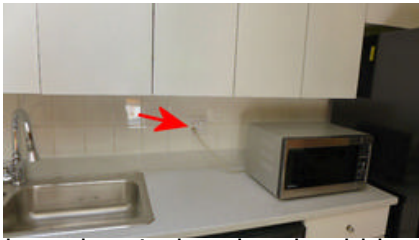
No ground fault circuit interrupter (GFCI) devices (outlets or circuit breakers) are visible for the kitchen. GFCI devices help prevent electric shocks in areas that may have water present. Recommend having a qualified, licensed electrician install GFCI protection for outlets, over counter tops and around sinks.

this kitchen electrical outlet should be GFI -ed.

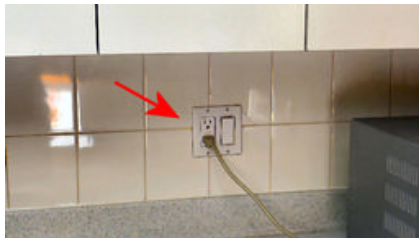
Closeup of kitchen electrical outlet that should be a GFI-ed

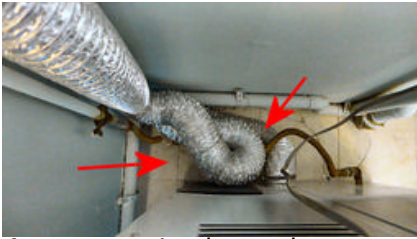
The clothes dryer is equipped with a vinyl or foil, accordion-type, flexible exhaust duct. The U.S. Consumer Product Safety Commission considers these types of ducts to be unsafe, and a fire hazard. As well as vent terminating into a woman's stocking into garage. These types of ducts can trap lint and are susceptible to kinks or crushing, which can greatly reduce the air flow. As well as increasing moisture levels in the garage from the exhaust air. This duct should be replaced with a rigid or corrugated semi-rigid metal duct, and by a qualified contractor if necessary. Most clothes dryer manufacturers specify the use of a rigid or corrugated semi-rigid metal duct. As well as terminate to the outdoors (Not inside garage or woman's stocking). For more information on dryer safety issues, see <http://www.cpsc.gov/CPSC/PUBS/5022.html>.

A compromised gas-dryer vent

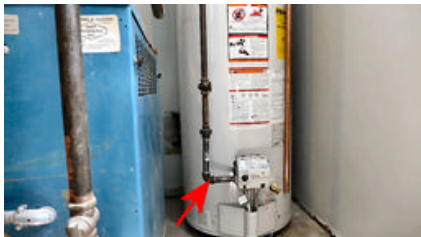
At the appliance connection point, there usually is a sediment trap or dirt pocket, sometimes called a drip leg that includes a nipple and a cap. This pipe extension usually is at least 3 inches long and is intended to catch any water or foreign material that may be in the gas before the material gets into the appliance itself. This is simply a gravity system, with the solids and liquids falling into the pocket.

Domestic hot water boiler. Missing drip-pipe element.

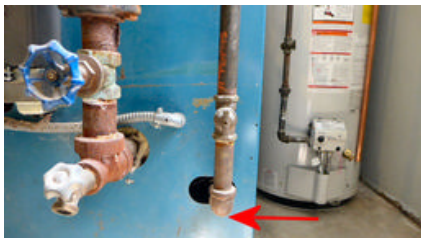
House heating furnace - missing drip-pipe element

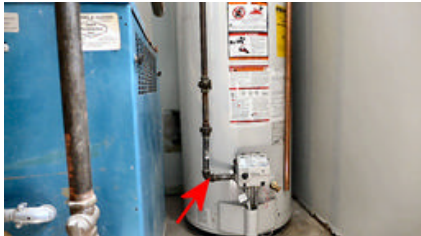
Gas line to hot water heater does not have a drip leg. This collects impurities in the gas to insure proper fuel burn. Without a drip leg, the impurities will create blockage in the fuel line leading to early unit failure and inefficient operation. Recommend a qualified contractor repair as necessary.

Domestic hot water boiler. Missing drip-pipe element.

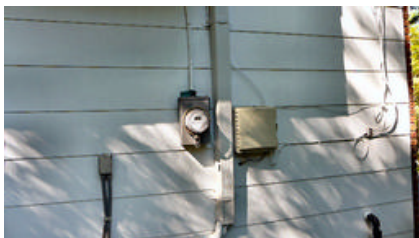
Noted a 100 amp service which is small by today's standard for this house size. Recommend considering installing a 200 amp service. Remember to have service drop cable changed to handle the additional current.

electrical service 100A meter

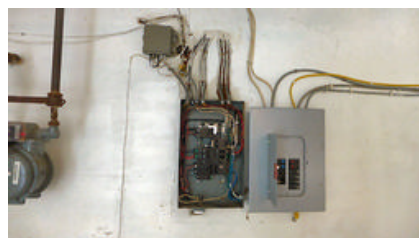
100A Electrical service panel
