Keyur Choksi
209 Sprain Rd.
Scarsdale, 10583
HIN™: 105834434
Email: keyur.choksi@gmail.com
Inspection Date: 06-07-2014

RHI
Andrew Rybak
1 Mark Lane Hopewell Junction, New York 12533
Phone: (845) 797-1656
E-Mail: andy@rybakhomeinspections.com

Full Report

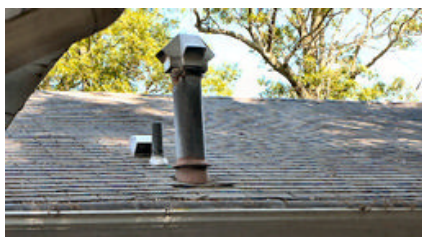
roof vents

06/19/2014 Noted lifting shingles tiles on roof. This may/will cause water intrusion. Recommend remediation by a qualified contractor.

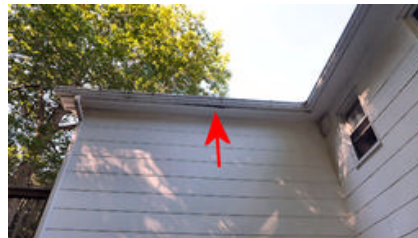
rotten wood behind the gutter - a closeup

06/19/2014 Recommend cleaning gutters. This will help keep water away from soffit surfaces and foundation.

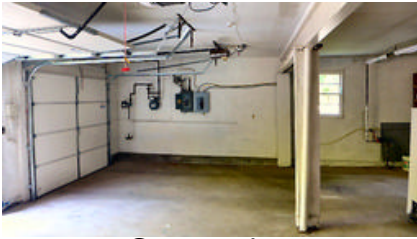
Garage view

Noted many garage floor settlement cracks. Probably the single most common reason for early cracks in concrete is plastic shrinkage. When the concrete is still in its plastic state (before hardening), it is full of water. This water takes up space and makes the slab a certain size. As the slab loses moisture while curing it gets a bit smaller. Because concrete is a very rigid material, this shrinking creates stress on the concrete slab. As the concrete shrinks, it drags across its granular subgrade. This impediment to its free movement creates stress that can literally pull the slab apart. When the stress becomes too great for the now hardened concrete, the slab will crack in order to relieve tension. i recommend a qualified contractor to assess the situation.

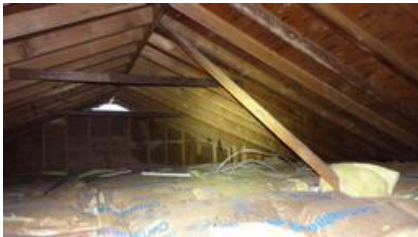
06/19/2014 There were no observable defects noted during my inspection of the attic space.

A view in the attic space view 2

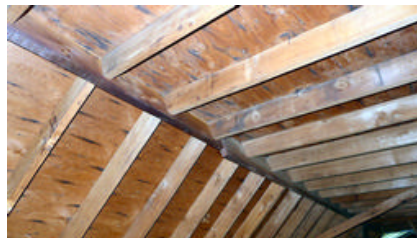
Attic space view 3

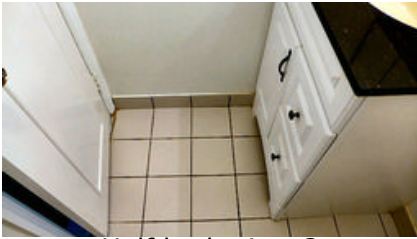
06/20/2014 No noted defects in bathroom.

Half bath view 2

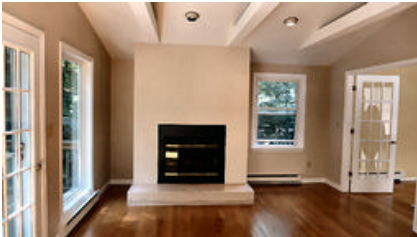
Interior. A fireplace.

Recommend a level 2 inspection performed by a qualified chimney sweep. This inspection will determine the condition of the flue liner.

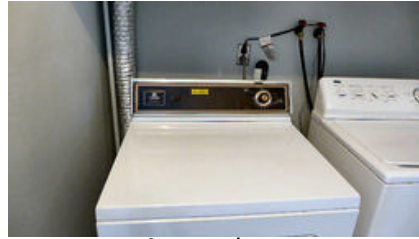
A gas dryer

06/20/2014 The clothes dryer is equipped with a vinyl or foil, accordion-type, flexible exhaust duct. The U.S. Consumer Product Safety Commission considers these types of ducts to be unsafe, and a fire hazard. As well as vent terminating into a woman's stocking into garage. These types of ducts can trap lint and are susceptible to kinks or crushing, which can greatly reduce the air flow. As well as increasing moisture levels in the garage from the exhaust air. This duct should be replaced with a rigid or corrugated semi-rigid metal duct, and by a qualified contractor if necessary. Most clothes dryer manufacturers specify the use of a rigid or corrugated semi-rigid metal duct. As well as terminte to the outdoors (Not inside garage or woman's stocking). For more information on dryer safety issues, see <http://www.cpsc.gov/CPSCPUB/PUBS/5022.html>.

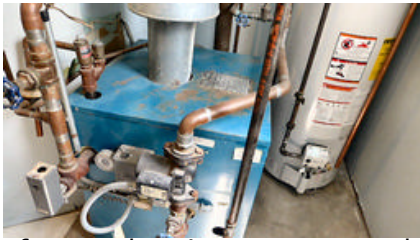
House furnace heating system - a closeup.

Gas line to hot water heater does not have a drip leg. This collects impurities in the gas to insure proper fuel burn. Without a drip leg, the impurities will create blockage in the fuel line leading to early unit failure and inefficient operation. Recommend a qualified contractor repair as necessary.

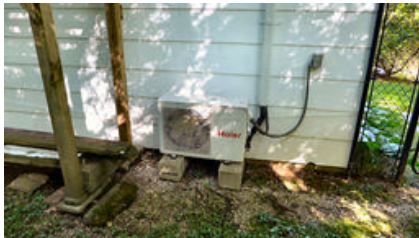
AC compressor - #3

06/20/2014 Air conditioner systems operated as designed on day of inspection.
